SERVICE BULLETIN

BT02-015

April 9, 2002

2002 ALTIMA; WIND NOISE DUE TO HOLE IN DOOR SEALER

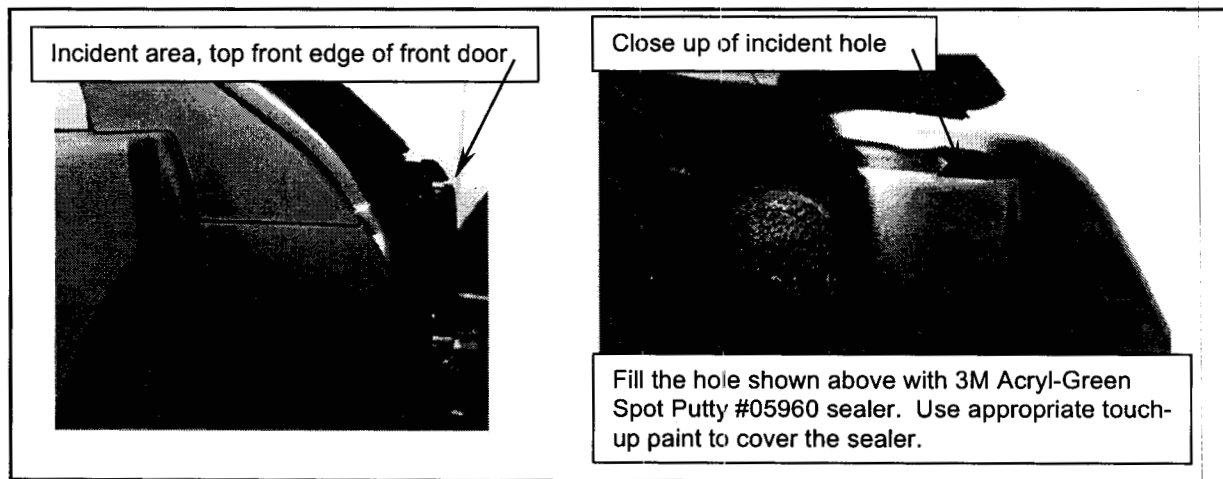
Figure 1

If a 2002 Altima exhibits wind noise (buzzing or whistling sound) around the left or right front door area, particularly in cross-wind conditions, there may be a hole in the door panel sealer at the front edge of the door.

Fill the area shown in figure 1 with 3M Acryl-Green Spot Putty #05960 sealer. Use appropriate touch-up paint to cover the sealer.
